Heat Resistance Test (130–190°C) for LEC-21 (Conductive LIFEL™ Sheet) Tray

**Test Tray Before Heat
Resistance Test**

Heat Resistance Test Results (Specimen Placed in Oven for Some Time and then Removed and Photographed)

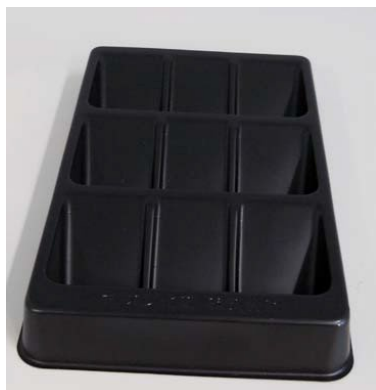
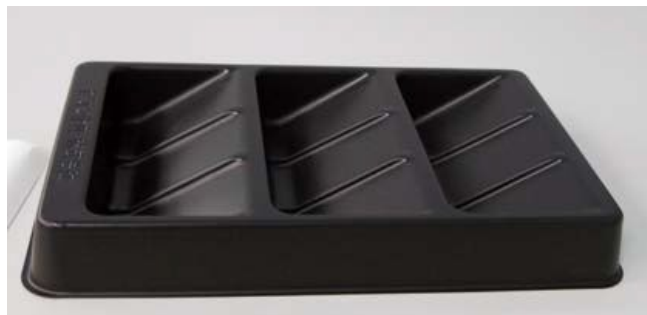
Front

Side

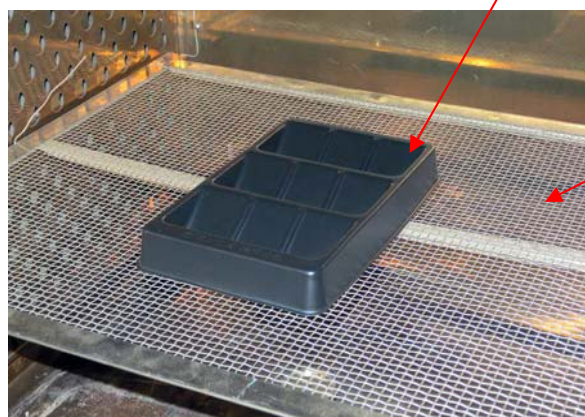
Metallic mesh
inside the gear
oven

Tray placement

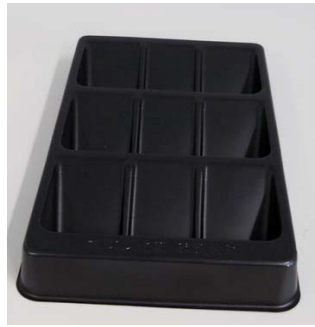
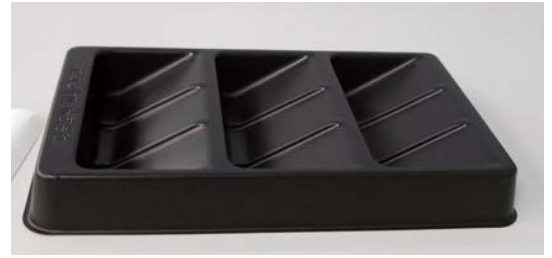
Room temperature
(before test)

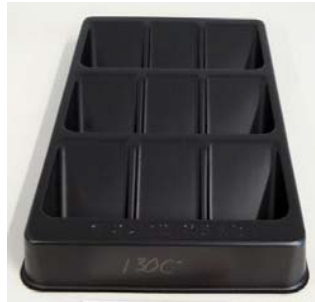
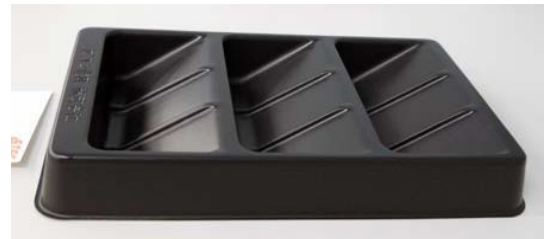
130°C, 1 hour
(no melting, no deformation)

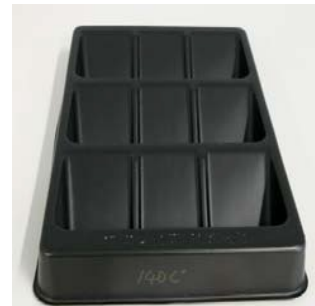
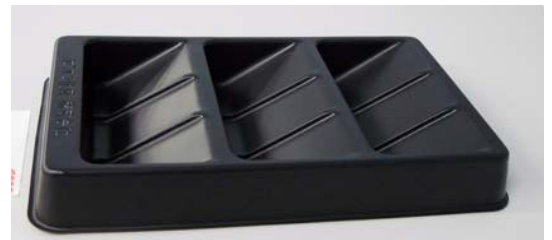
140°C, 1 hour
(no melting, no deformation)

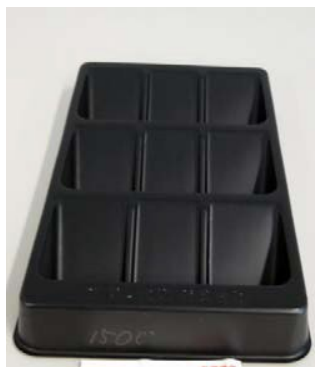
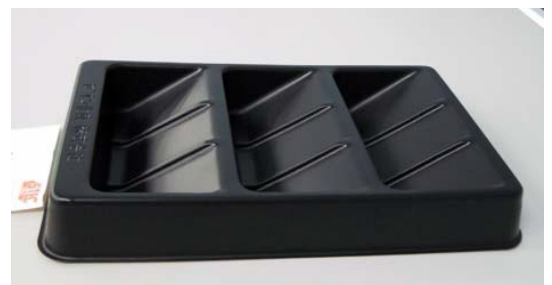
150°C, 1 hour
(no melting, no deformation)

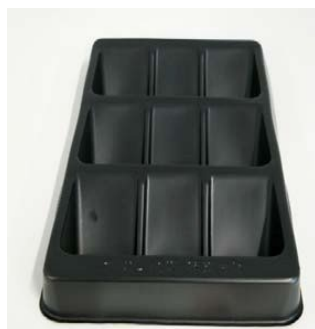
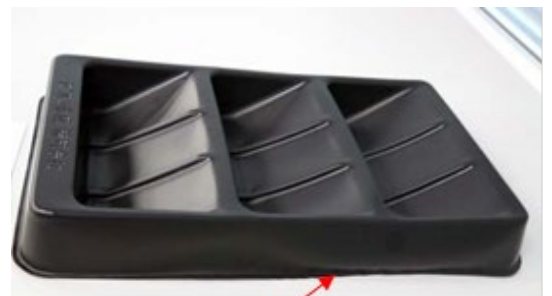
160°C, 1 hour
(no melting, deformation appears
at the bottom)

Deformed

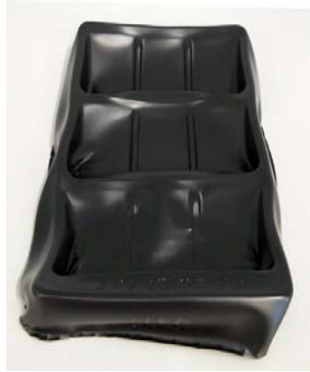
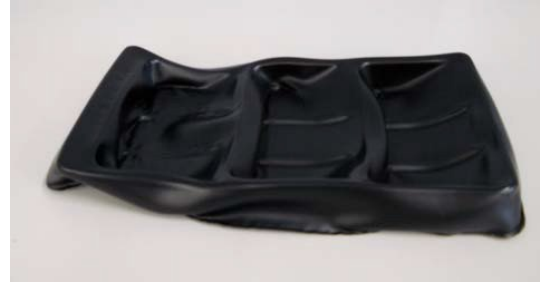
165°C, 30 minutes
(melted, deformed)

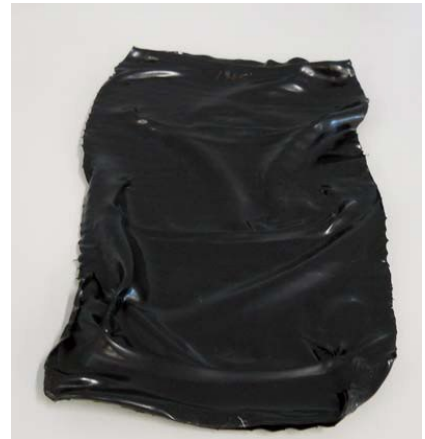
180°C, 10 minutes
(melted and slightly deformed, original shape is lost, imprinted with metallic mesh marks, precipitation of inorganic components is not visible)

Specimen became further deformed further when stripped of the metallic mesh. The same conditions occurred in the 180°C test before it was stripped of the metallic mesh.

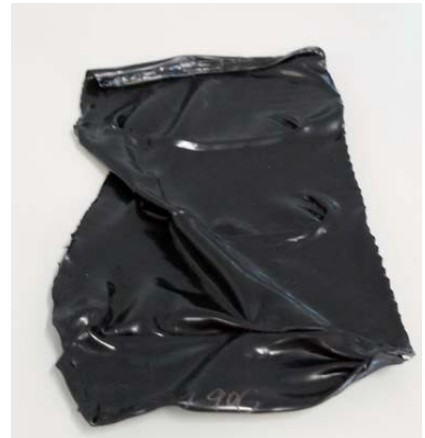
190°C, 10 minutes
(melted and heavily deformed, original shape is lost, clearly imprinted with metallic mesh marks, precipitation of inorganic components is not visible)
